# Traffic Accident Reduction for SWINDON BOROUGH COUNCIL

**PROBLEM IDENTIFIED** Swindon Borough Council identified an accident blackspot at Buscot Bend, near Lechlade on the outskirts of Swindon. The road layout featured a gentle rise to a blind summit with a bend over the brow. Motorists were occasionally experiencing difficulties negotiating this hidden bend safely, which resulted in several drivers overrunning into the adjacent field.

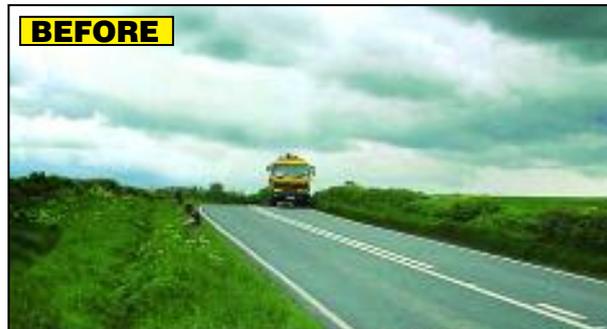
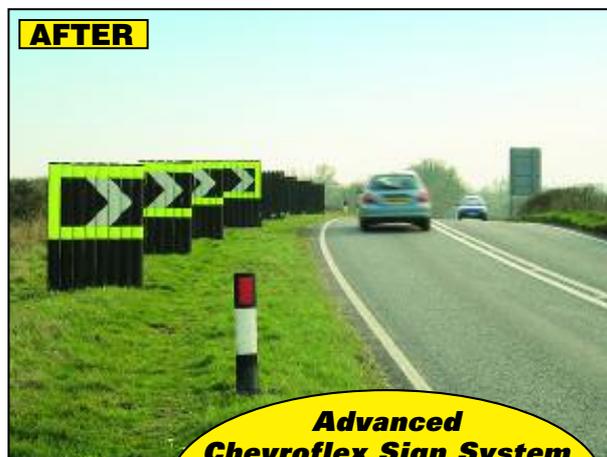
**Advanced Chevroflex Sign System has been installed to sign Buscot Bend from each approach**

In the event of a drive-through incident, unlike conventional signs, Advanced Chevroflex Sign System has flexible uprights which bend on impact and substantially return to their vertical position. This ensures that the hazard is still clearly signed. There is a reduced risk of serious injury to motorists and motorcyclists.
